# Manhole Inspection Summary

Manhole # S05II2047MH

**Inspection** ☐ Is Incomplete Rating: **3) Fair**

**Location** Address: **6318 GREENSPRING AVE**

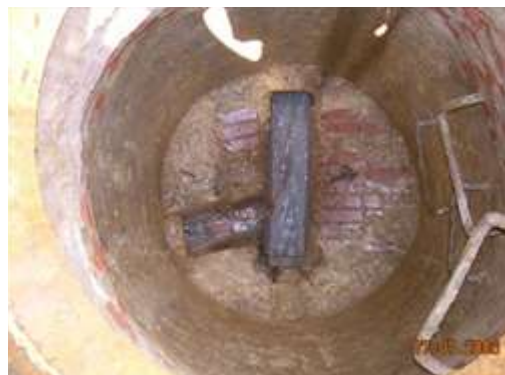
Top View

Frame leaks. Adjustment and Corbel infiltration. Bench debris.

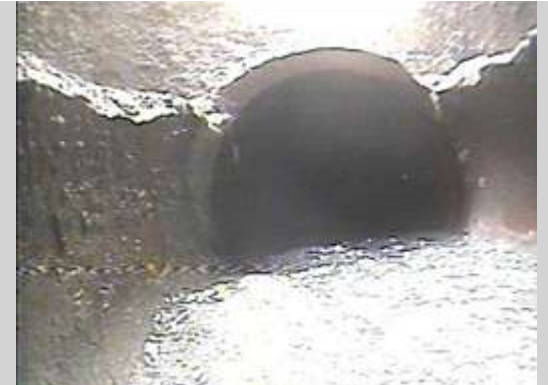
### 10 in. Circular Gravity Sewer Pipe Out @ 12 O'Clock

Pipe Material: **Clay** ☐ Pipe Lined

Invert Depth: **8.76** (ft.) Flow Characteristics: **Fast**

Infiltration: **None** Pipe Seal Cond: **Unknown**

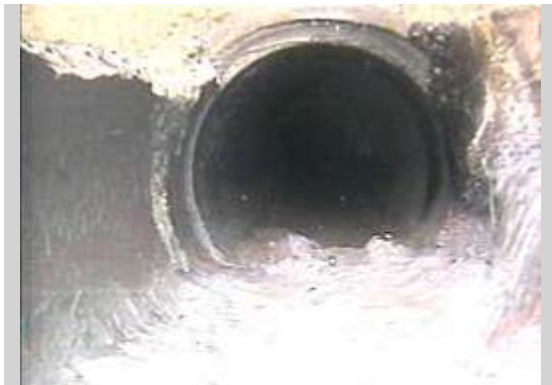
### 10 in. Circular Gravity Sewer Pipe In @ 6 O'Clock

Pipe Material: **Clay** ☐ Pipe Lined

Invert Depth: **8.70** (ft.) Flow Characteristics: **Fast**

Infiltration: **Evidence** Pipe Seal Cond: **Unknown**

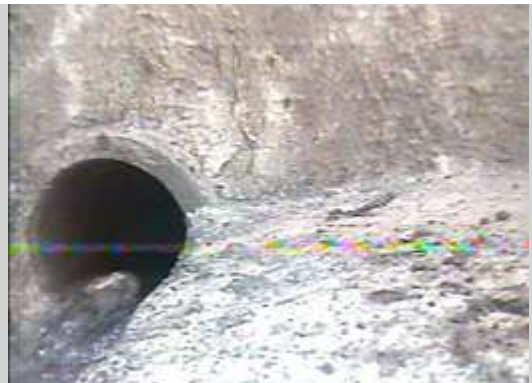
6 in. Circular Gravity Sewer

Pipe Material: **Clay**

Invert Depth: **8.19** (ft.) Flow Characteristics: **Slow**

Connects To: **House connection / Service line**
